THE MONUMENTAL GATE AT TOL-E AJORI, PERSEPOLIS (FARS): NEW ARCHAEOLOGICAL DATA

Alireza ASKARI CHAVERDI¹, Pierfrancesco CALLIERI² & Emad MATIN²
(¹ Shiraz University; ² University of Bologna)

Abstract: Thanks to new evidence brought to light in 2015 at Tol-e Ajori, Persepolis (Fars), further information has been acquired on two fundamental architectural aspects, the technique of construction on one hand, and the plan of the inner room on the other. A third important objective, the topographic context of the Gate, has also benefited from new information, which is however insufficient to complete the picture. Finally, interpretation of the destruction phase of the Gate has also been further advanced.

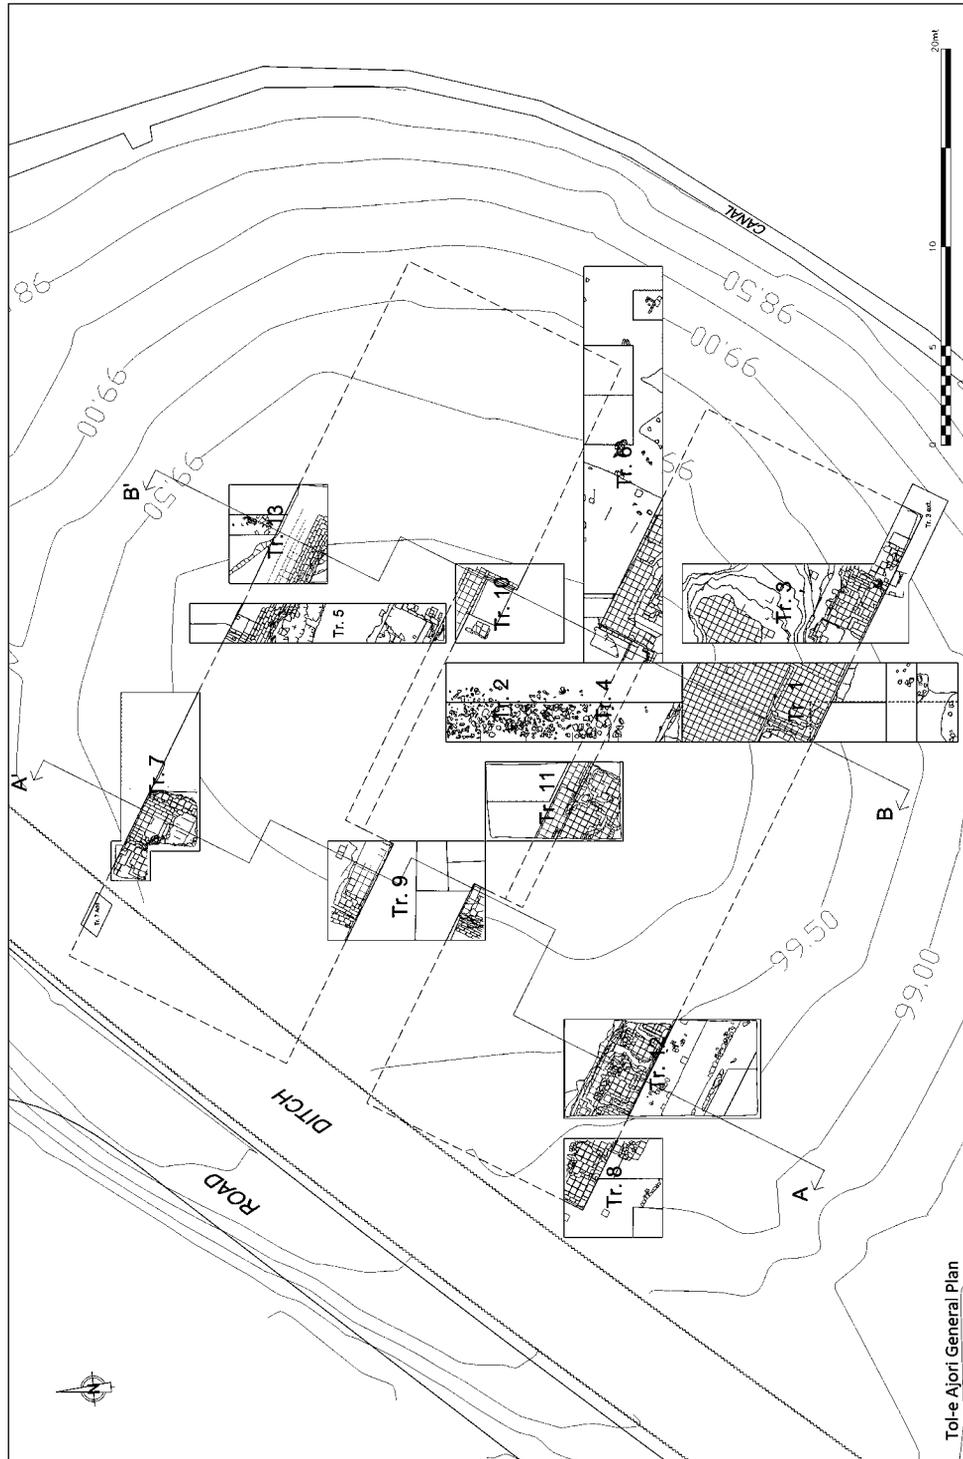
Pl. 1. Tole-e Ajori: general plan (©Iranian-Italian Joint Archaeological Mission, drawing S. Thiia).

In Autumn 2015 the fifth excavation season was carried out at the monumental gate at Tol-e Ajori, 3.5 km to the NW of the Persepolis Terrace in the area of Bagh-e Firuzi¹. Three new trenches were opened (Pl. 1).

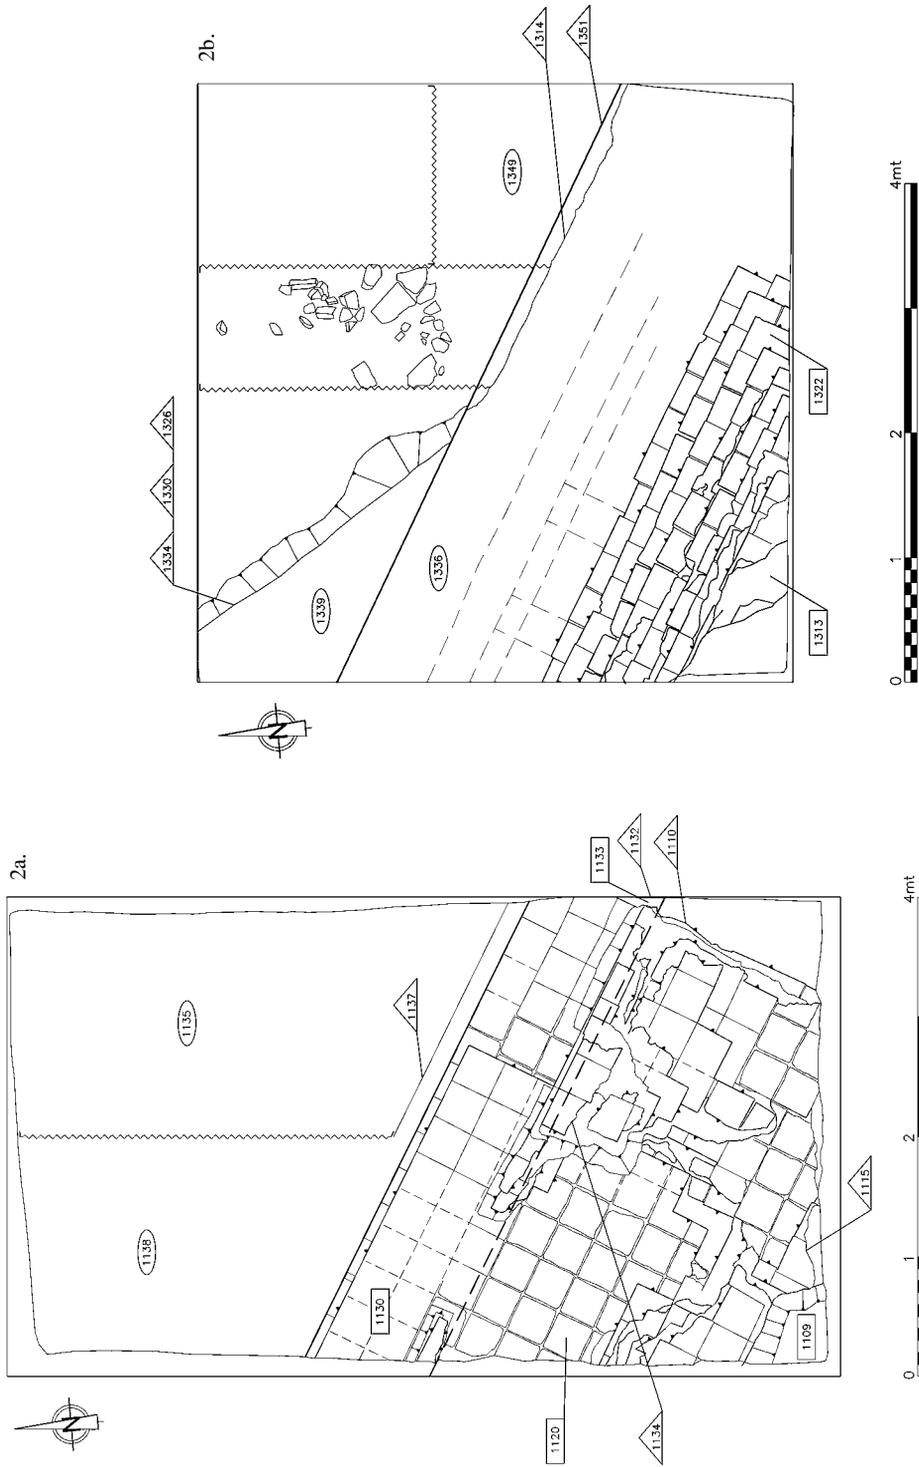
Tol-e Ajori Tr. 11

Pl. 2a. Tol-e Ajori, Trench Tr. 11: plan at the end of the 2015 campaign (©Iranian-Italian Joint Archaeological Mission, drawing S. Tilia);
 Pl. 2b. Tol-e Ajori, Trench Tr. 13: plan at the end of the 2015 campaign (©Iranian-Italian Joint Archaeological Mission, drawing S. Tilia).

Trench Tr. 11 (7 × 11 m, with N-S main axis) was excavated immediately SE of Trench Tr. 9 in order to study the inner room of the Building and the inner face of the southern wall (Pl. 2a).

As regards the area facing the walls, in Trench Tr. 11 the N limit of the foundation trench of the wall of the inner room was easily distinguished on the surface of the uppermost layer of the pre-building phase²¹. This cut²² runs parallel to the foundation²³ at a distance of c. 0.15 m from it and to a depth of c. 0.50 m (Pl. 2a, 5b).

In Trench Tr. 13 the limit of the foundation trench was also evidenced in the trial trench excavated in the E part of the outer area, to the N of the wall robbery trench which pillaged most of the baked bricks of the NE wall of the Gate²⁴ — a wall which nevertheless left its impression in the adjoining stratification. Here a foundation trench²⁵ almost parallel to the baked bricks Block A of the wall was cut in the existing soil layer²⁶ for a height of c. 0.35 m, 0.10 m wider than the wall (Pl. 2b).

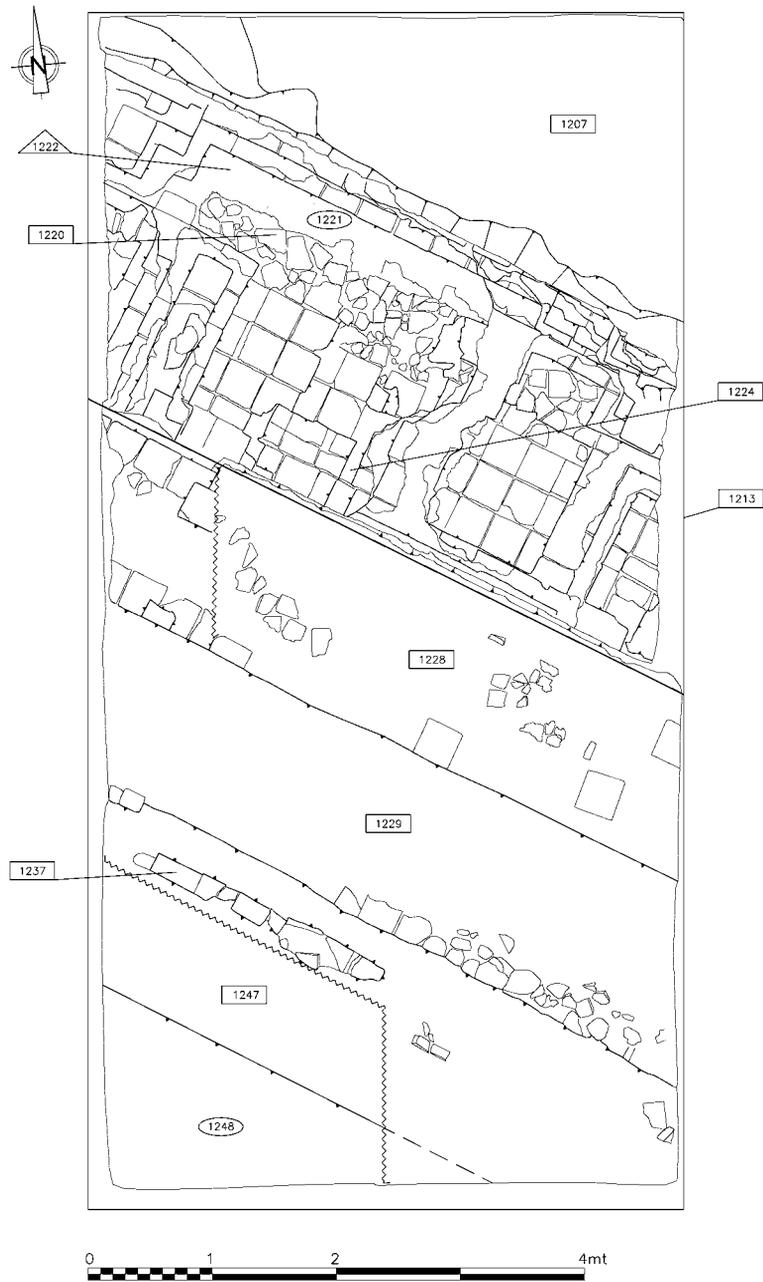
Tol-e Ajori Tr. 12

Pl. 3. Tol-e Ajori, Trench Tr. 12: plan at the end of the 2015 campaign
 (©Iranian-Italian Joint Archaeological Mission, drawing S. Tilia).

Trench Tr. 12 (10 × 5 m, with N-S main axis) was excavated one meter E of Trench Tr. 8 to examine the external stratigraphy of the Building, the condition of the south-western wall and the possible presence of an external wall adjoining to the Building (Pl. 3).

In Trench Tr. 12, the pre-building clayey soil¹⁰ (Pl. 3) was only exposed at the bottom of the foundation trench (see below). Another possible area of this layer¹¹ was exposed at the foot of the structure adjoining the Gate to the SW¹². In both the loci, the soil consists of pure and compact clay of a yellowish colour.

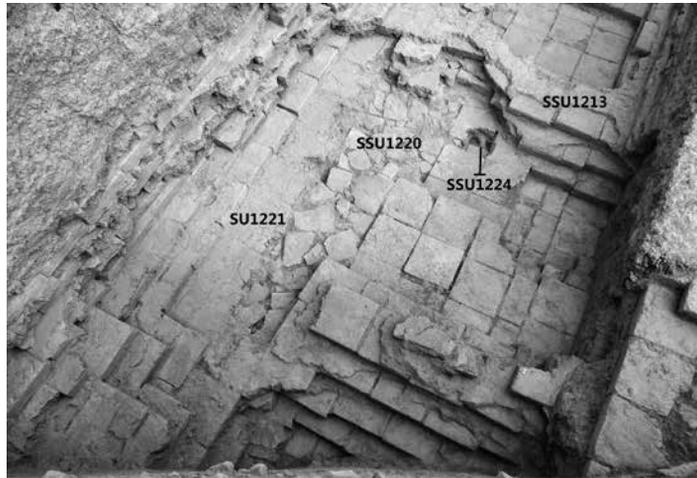
- Pl. 4a. Tol-e Ajori, Trench Tr. 12: impression of bricks on the pre-building soil SU1221, courses of broken bricks SSU1220 and channel for drainage SSU1224 (©Iranian-Italian Joint Archaeological Mission, elaboration A. Tare);
- Pl. 4b. Tol-e Ajori, Trench Tr. 13: impression of bricks on the pre-building soil SU1336, baked bricks Block A and Block B, below the mud-brick Block C (©Iranian-Italian Joint Archaeological Mission, elaboration A. Tare).

In Trench Tr. 12 this system is further implemented with a small channel³⁸, obtained by leaving a distance of 0.10 m between two baked bricks of the second lowermost course of Block A, found filled with a later loose filling³⁹ (Pl. 4a). The presence of small channels recorded between the courses of baked bricks is also described by R. Koldewey at Babylon (Koldewey 1914: 84), having the same aim of securing the dryness of the building.

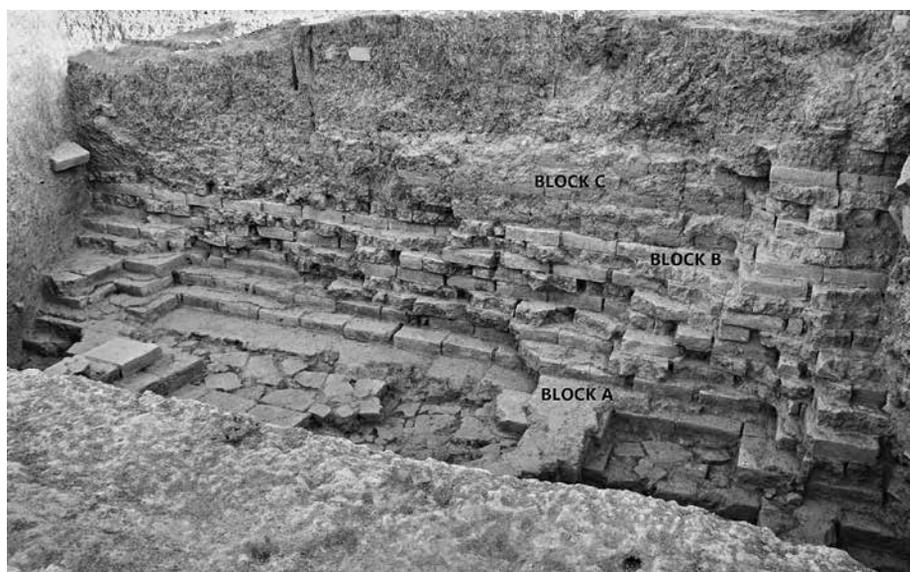
Pl. 5a. Tol-e Ajori, Trench Tr. 12: baked bricks Block A and Block B, below the mud-brick Block C (©Iranian-Italian Joint Archaeological Mission, elaboration A. Tare);
 Pl. 5b. Tol-e Ajori, Trench Tr. 11: benches and stretch of the inner room Block D wall with glazed bricks decoration in situ. The remarkable forward shifting of the upper portion of the wall is visible above the damaged lower part (©Iranian-Italian Joint Archaeological Mission, elaboration A. Tare).

of preventing moisture from underground to rise in the elevation of the core. Throughout the length of the trench, the section of baked bricks below the mud-brick exceeds by six courses the six courses of the Block A foundation, and thus the baked-brick elevation Block B extends towards the core below the mud-brick Block C; moreover, in a band measuring two-three bricks adjacent to the E limit of the trench, the baked brick section rises by four more bricks, reaching a total number of ten courses above the six foundation courses (Pl. 5a). This could mean that the mud-brick section filled a grid of baked bricks, strengthening the whole structure.

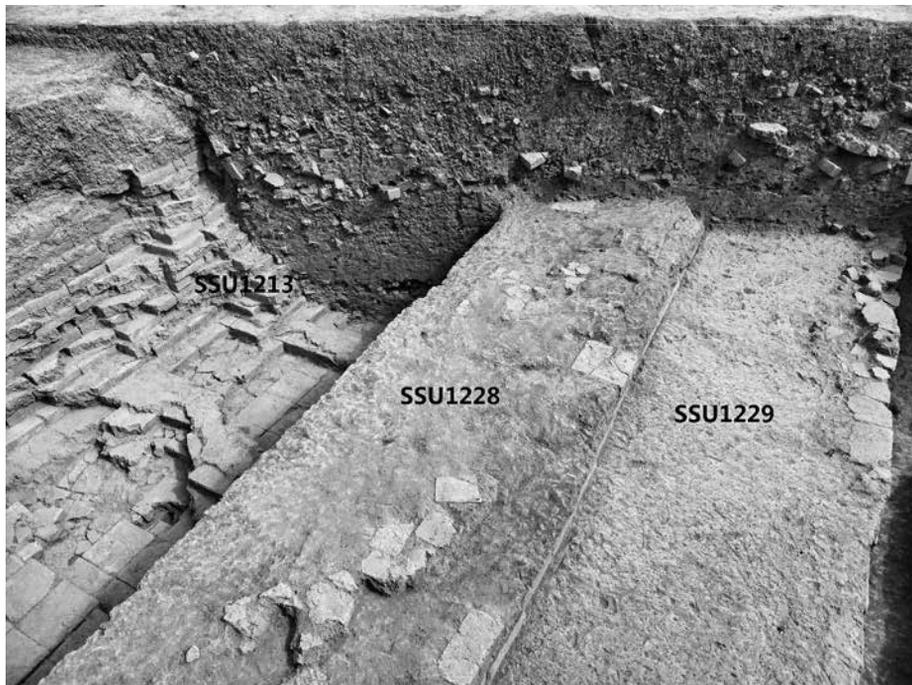
Pl. 6a. Tol-e Ajori, Trench Tr. 12: external structures SSU1228 and SSU1229 leaning against the (pillaged) baked bricks section SSU1213 (©Iranian-Italian Joint Archaeological Mission, elaboration A. Tare);

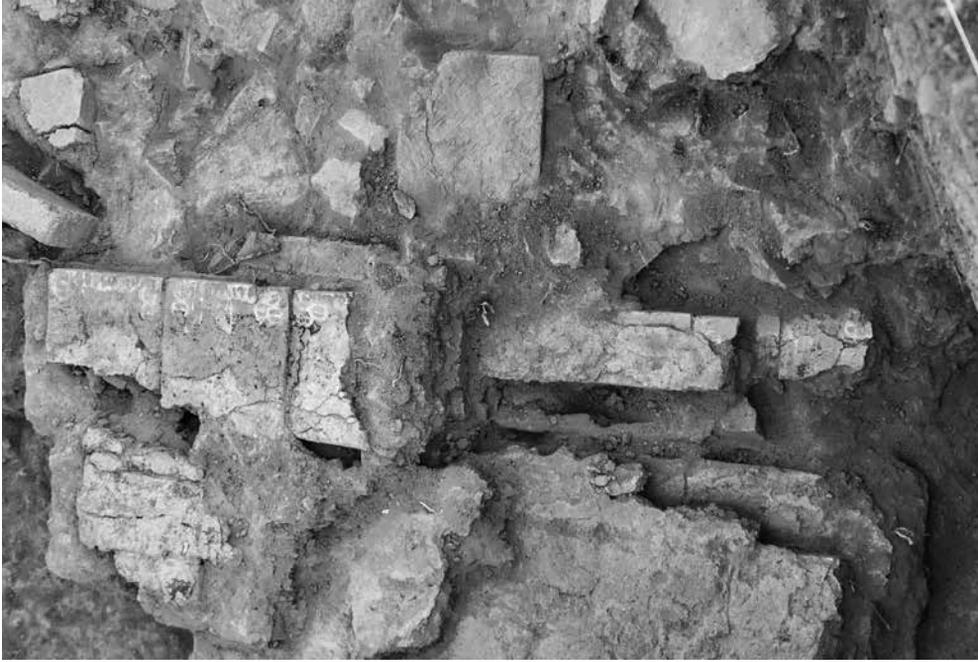
Pl. 7a. Firuzi 5: general plan (©Iranian-Italian Joint Archaeological Mission, drawing S. Tilia);
 Pl. 7b. Tol-e Ajori: Trench Tr. 11, wall SSU1120 with fracture NSU1134 of possible seismic origin
 (©Iranian-Italian Joint Archaeological Mission).

The lower courses of the wall elevation were damaged by this disastrous event, while the portion above is perfectly vertical and still shows its well-preserved glazed decoration, although horizontally shifted by 0.10 m to NE (Pl. 7b). This situation prevented excavation of the whole portion below the shift, which, in order to prevent the preserved part above it from crumbling, was only investigated in a 0.50 m-long stretch: this short stretch shows in the brick courses from the second to the fifth from the bottom the effects of a strong compression and horizontal movement of the further portion of the wall. Above this damaged portion, the glazed brick courses are, by contrast, well-preserved; they were described in the preceding pages.

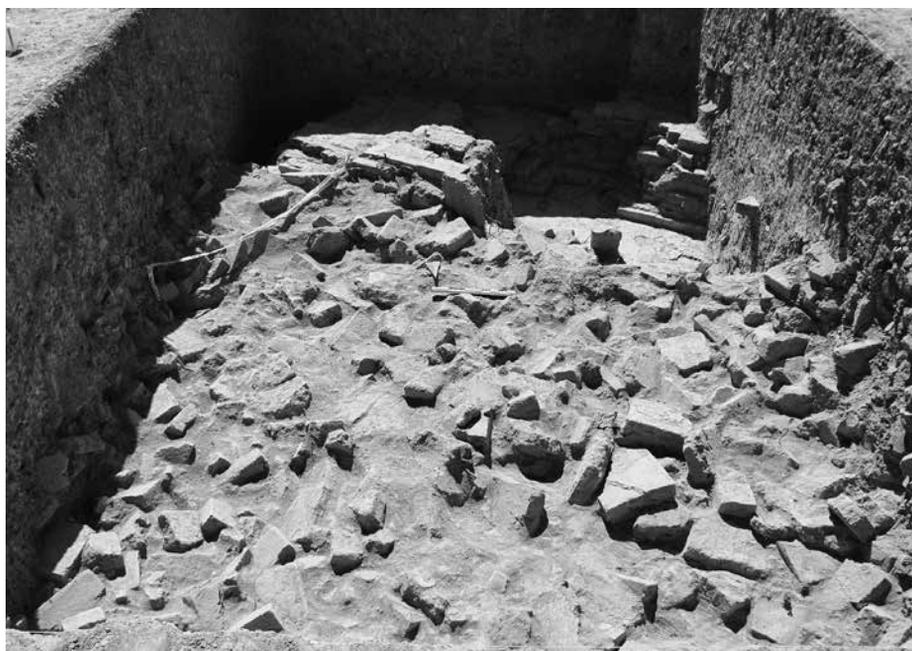
- Pl. 8a. Tol-e Ajori: Trench Tr. 11, collapse layer SU1124 (©Iranian-Italian Joint Archaeological Mission);
- Pl. 8b. Tol-e Ajori: a flat polychrome glazed brick fragment, Reg. No. GB00695. (©Iranian-Italian Joint Archaeological Mission, photo N. Ibnoerrida).

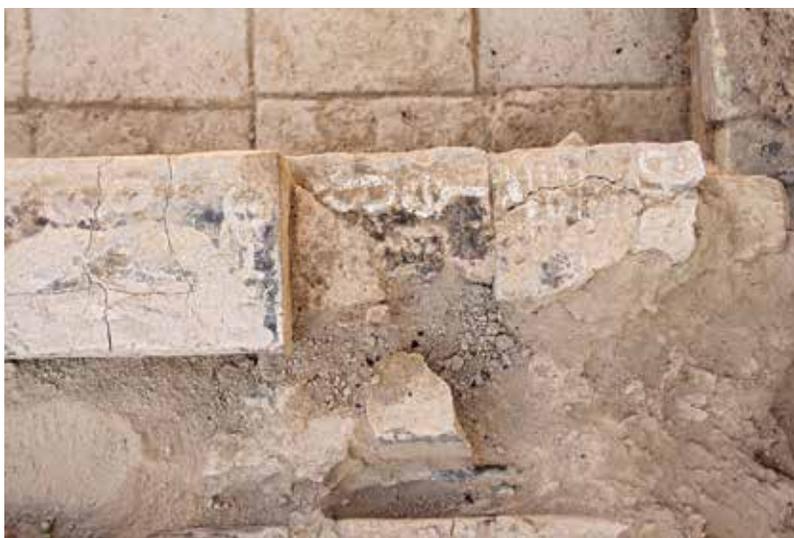
Pl. 15a. Tol-e Ajori, Trench Tr. 11: part of the monument wall found in situ. The fitters' marks are visible on upper surface of the bricks (©Iranian-Italian Archaeological Mission, photo D.M. Meucci);

In the 2015 season in Trench Tr. 11 a stretch of the elevation of the wall of the inner room was found preserved from the subsequent pillage, in a reasonably good state of conservation. The wall as usual consisted of a baked-brick section⁴⁵ (Block D) and a mud-brick section⁴⁶ (Block C): the outermost part for a thickness of 2.50 m had an elevation entirely constructed in baked bricks, while the mud-brick sections lay on some courses of baked bricks section, with no uniform number of courses. The outermost three-four rows of baked bricks of Block D used bitumen as mortar, as visible from what was left by the wall robbery trench. The NE face of Block D, above the course of unglazed bricks set back by 0.035 m, was built with glazed bricks, of which eleven courses are preserved for a 2.70 m long stretch. The lower ones were damaged by a disastrous event while the portion above still shows its well-preserved glazed decoration, even though it was horizontally shifted by 0.10 m to NE. In view of this situation, to avoid the risk of collapse it was decided not to excavate the whole portion below the shift, which was only investigated in a 0.50 m long “window”, showing in the courses from the second to the fifth from the bottom the effects of strong compression and horizontal movement, possibly caused by an earthquake (see “Destruction of the Gate Process”). Above this damaged portion, the glazed-brick courses are well-preserved and show from the bottom upwards: a band composed by a course with alternating yellow, white and dark squares between two courses of monochrome yellow bricks and two courses belonging to a band of open rosettes in dark ground above a monochrome dark course (Pl. 5b). This is the same composition as the one discovered in Trench Tr. 9, and corresponds exactly to that of the Ishtar Gate, with a difference in the present preservation of the blue glaze. Another interesting feature of this portion of wall consists in the fitters’ marks, well preserved on the upper face of the glazed bricks under the bitumen mortar: here the meaning of the central fitters’ mark could be effectively understood in relation to the course position.

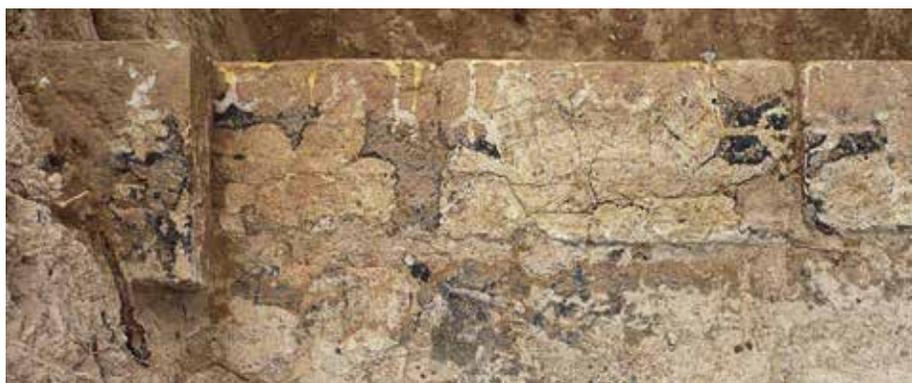
Pl. 16a. Tol-e Ajori, Trench Tr. 1: part of the monument wall found in situ. The fitters' marks are visible on upper surface of the bricks (©Iranian-Italian Archaeological Mission, photo A. Mercuriali);

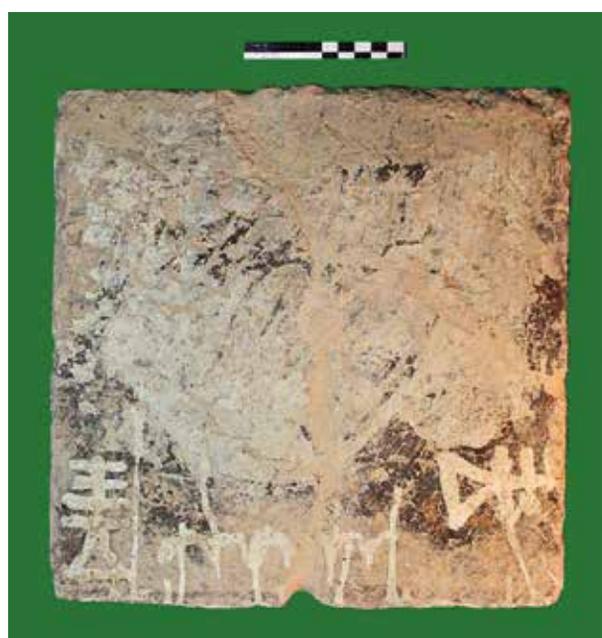
Pl. 16b. Tol-e Ajori: the upper surface of a flat polychrome brick fragment with fitters' marks, Reg. No. GB01743. (©Iranian-Italian Archaeological Mission, photo P. Severi).

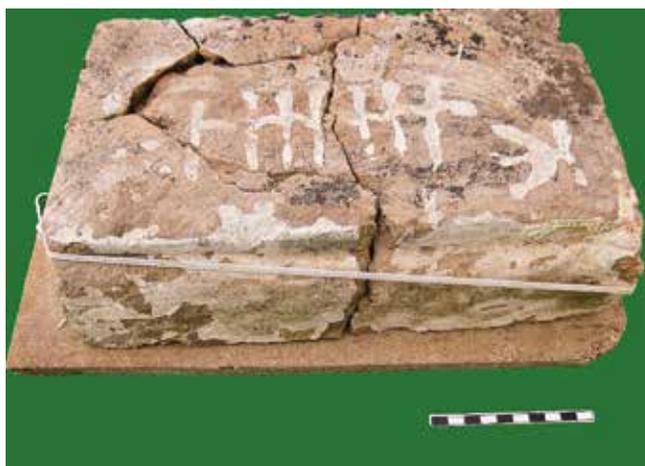
Pl. 17a. Tol-e Ajori: a relief glazed brick fragment showing fitters' marks, Reg. No. GB00273. (©Iranian-Italian Archaeological Mission, photo L. Tortella);
